## BCM 3.6/SRG 1.0 WLAN IP Telephony Patch Release Notes

Abstract: This document describes the content changes in BCM 3.6/SRG 1.0 WLAN IP Telephony Patch.

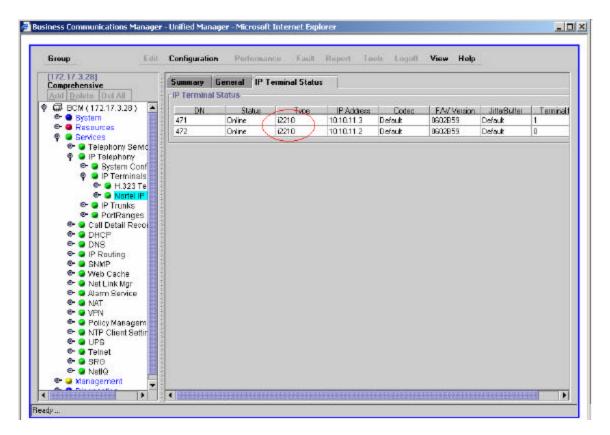
#### GUI 2:

The i2210 or i2211 are represented as such in Unified Manager under BCM>>Services>>IP Telephony>> IP Terminals>>Nortel IP Terminals under IP Terminal Status (see limitation #6 in Limitations section). Please refer to GUI2.
