CallPilot - RAID Firmware Update

Problem Description

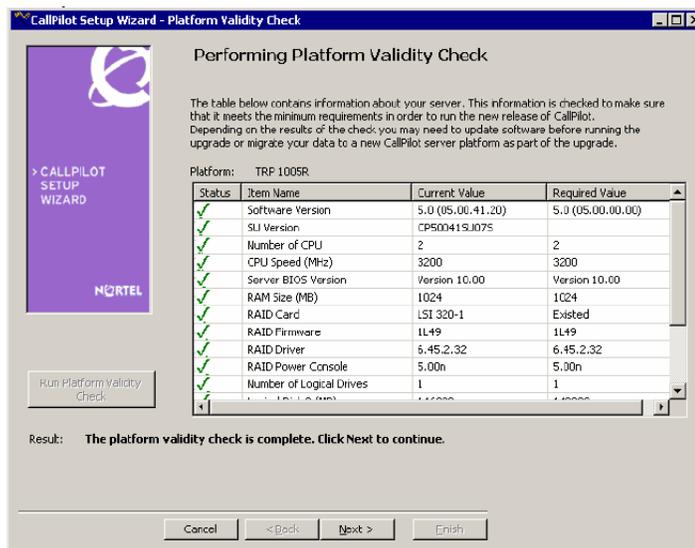
1. Confirm the CallPilot server's current type of RAID subsystem (RAID controller, firmware version, and Power Console application version) by launching the Setup Wizard (Start > Programs > CallPilot > Setup Wizard) and going to section "**Platform Validity Check**".

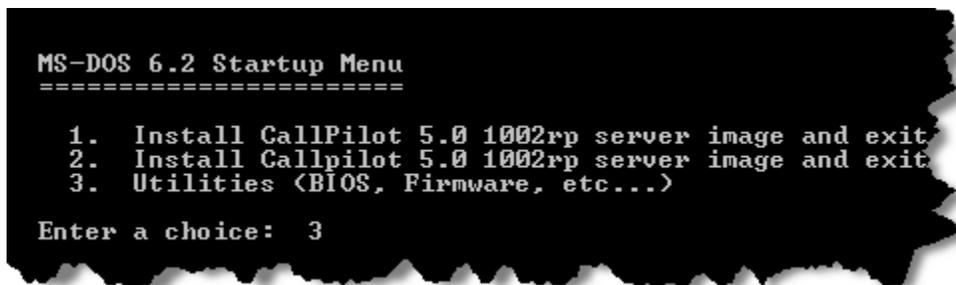
```
MS-DOS 6.2 Startup Menu
=====
 1. Install CallPilot 5.0 1002rp server image and exit
 2. Install Callpilot 5.0 1002rp server image and exit
 3. Utilities <BIOS, Firmware, etc...>

Note: This screen may be different on other platforms and CallPilot versions.

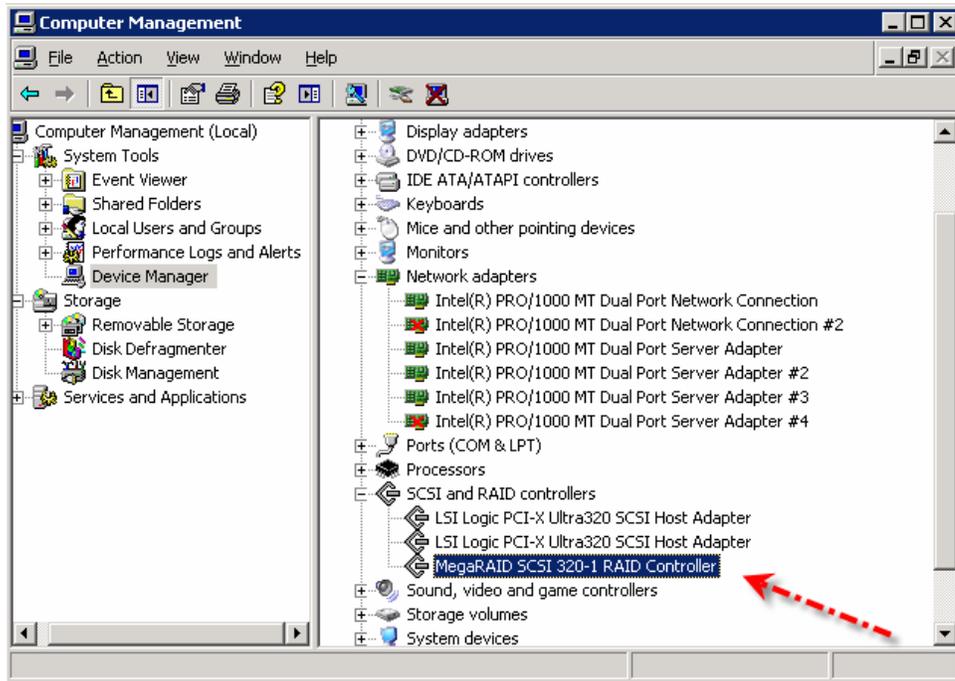
6. Open “Device Manager” and double-click to expand “SCSI and RAID controllers”.

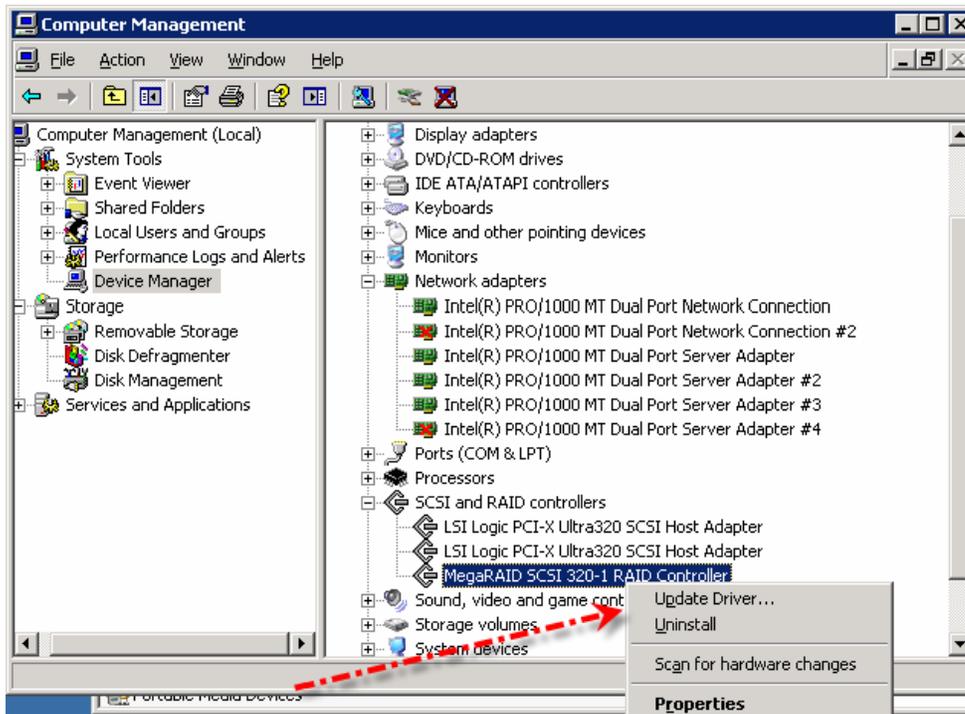
7. Right-click on “Mega RAID SCSI 320-I RAID Controller”.

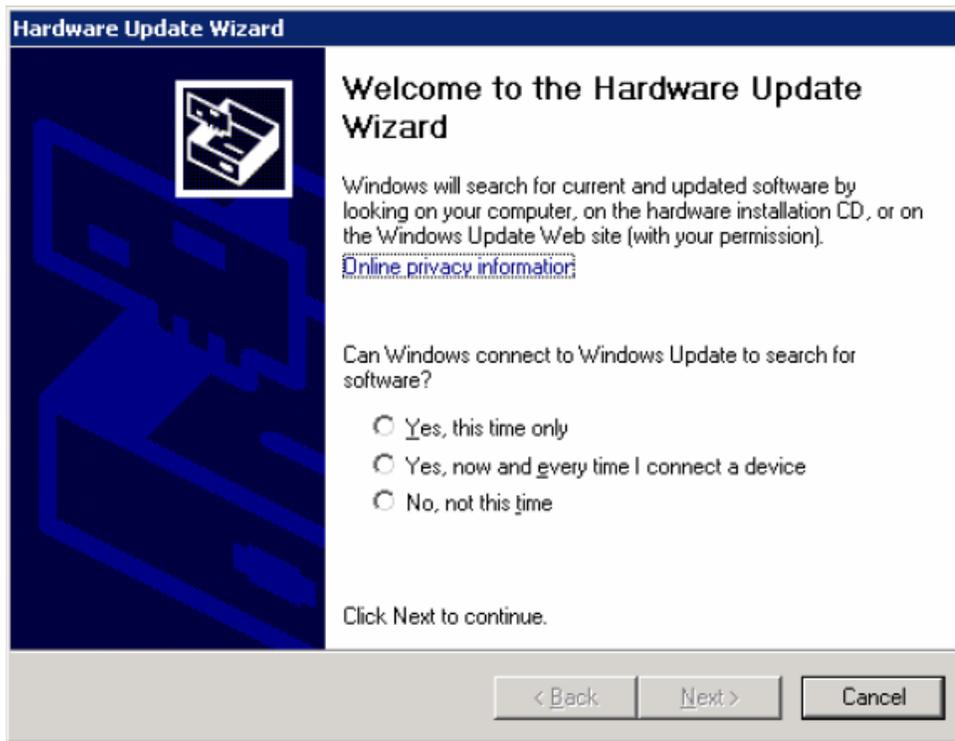
8. The “Hardware Update Wizard” welcome screen appears.

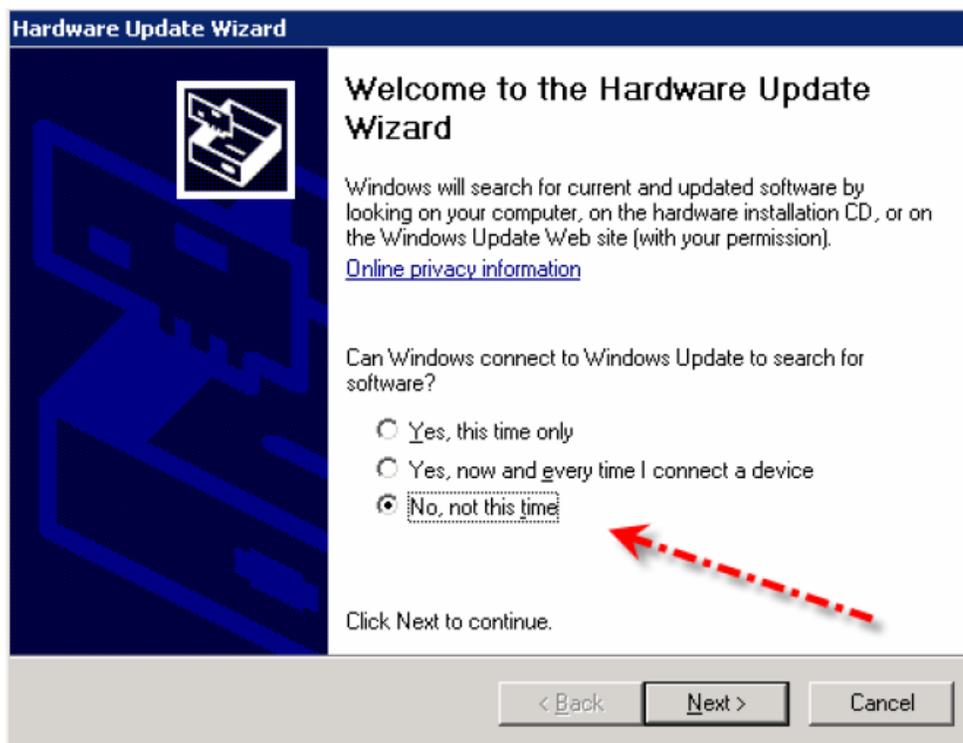
9. Select “No, not this time” and click “Next >” to continue.

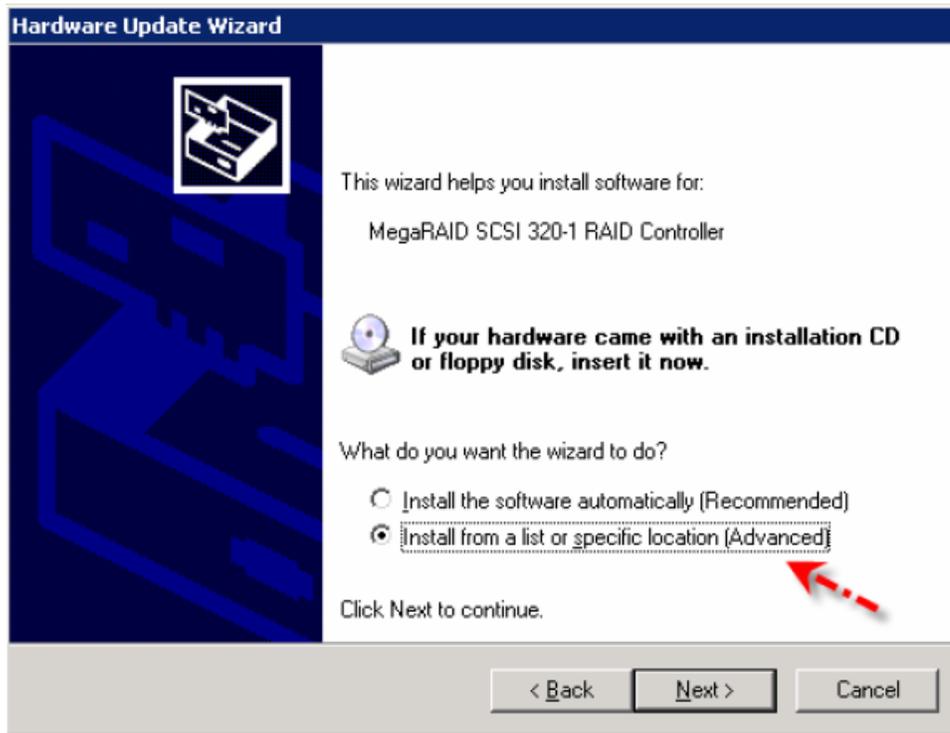
10. Select “Install from a list or specific location (Advanced)” and click “Next >”.

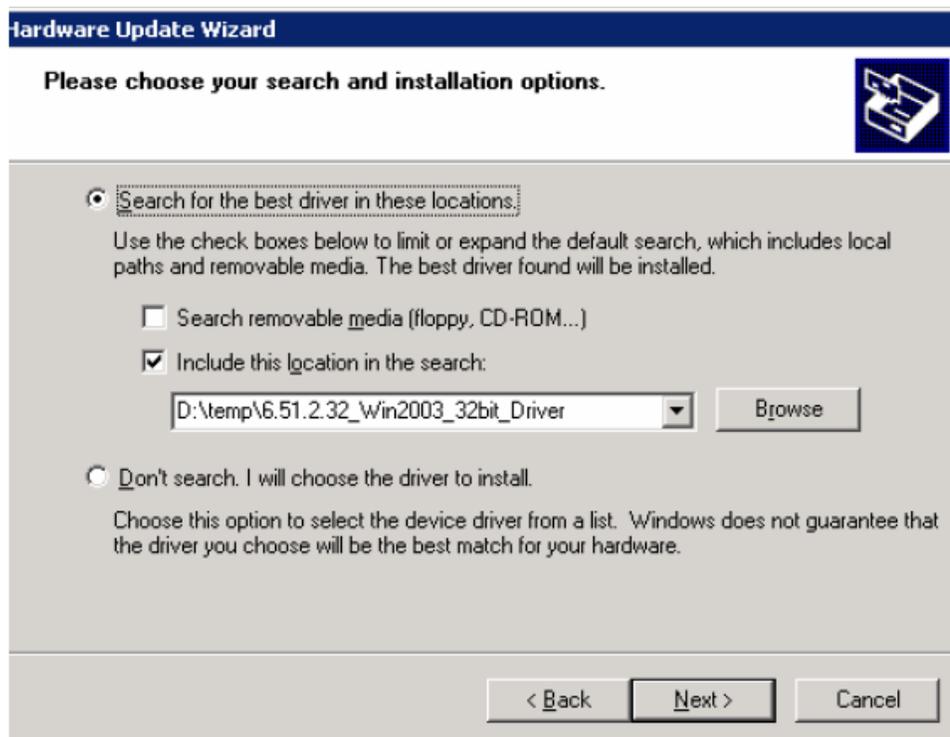
11. Navigate to (and include) the directory where the “6.51.2.32_Win2003 Server_32bit_driver” are located and then select “Next >”.

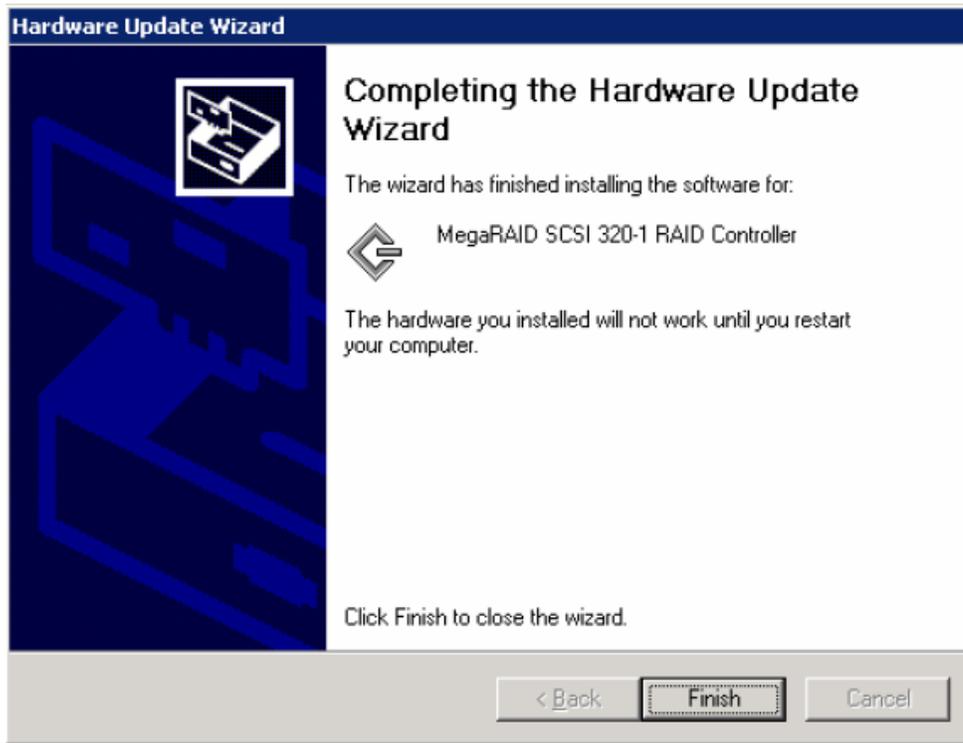
12. The wizard will apply the updates and the following window will appear.

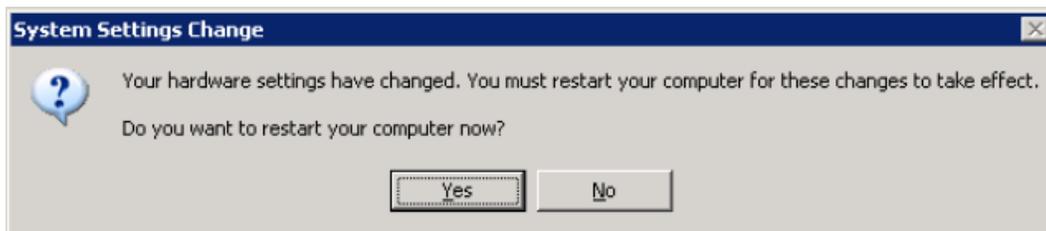
13. Click "Finish".

14. Click "Yes" to reboot.

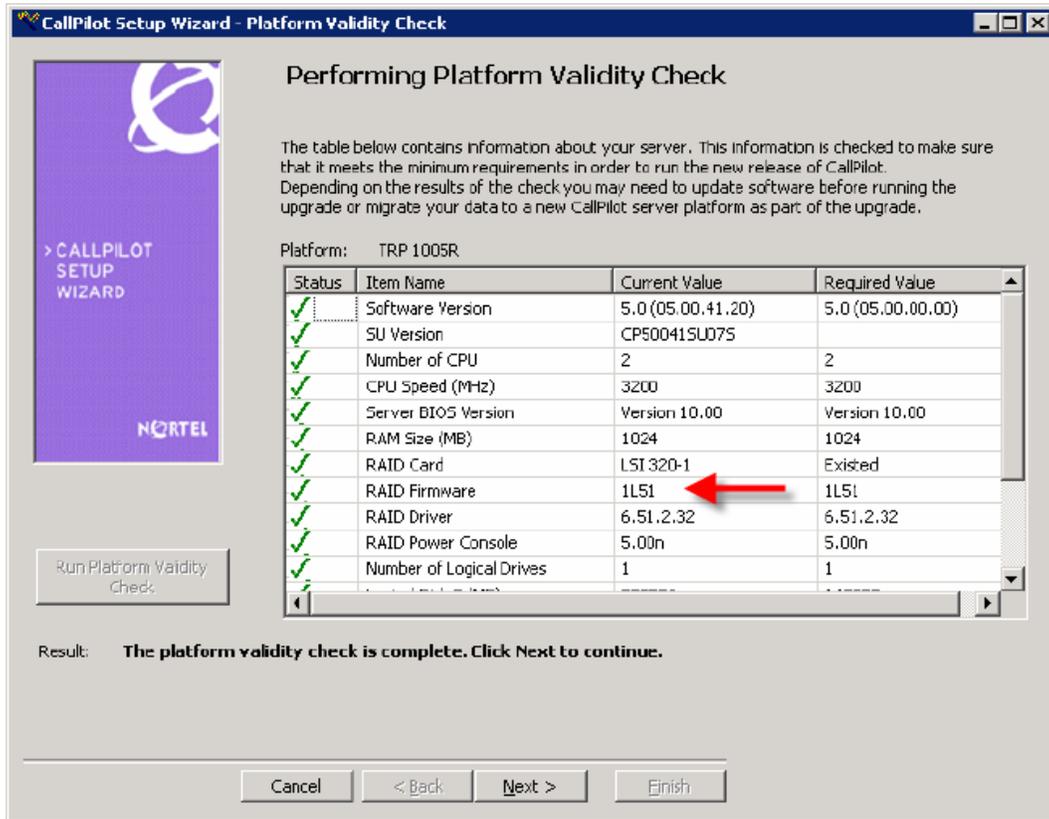
15. All steps required to update the RAID firmware are now complete. Once the reboot completes, the Setup Wizard will appear as follows with the RAID firmware reflecting version 1L51.
