General Release Bulletin

Bulletin Number: GR 2003-0368-Global

Nortel Networks Meridian/Succession Systems

**Succession Enterprise 3.0 Software
General Release Bulletin**

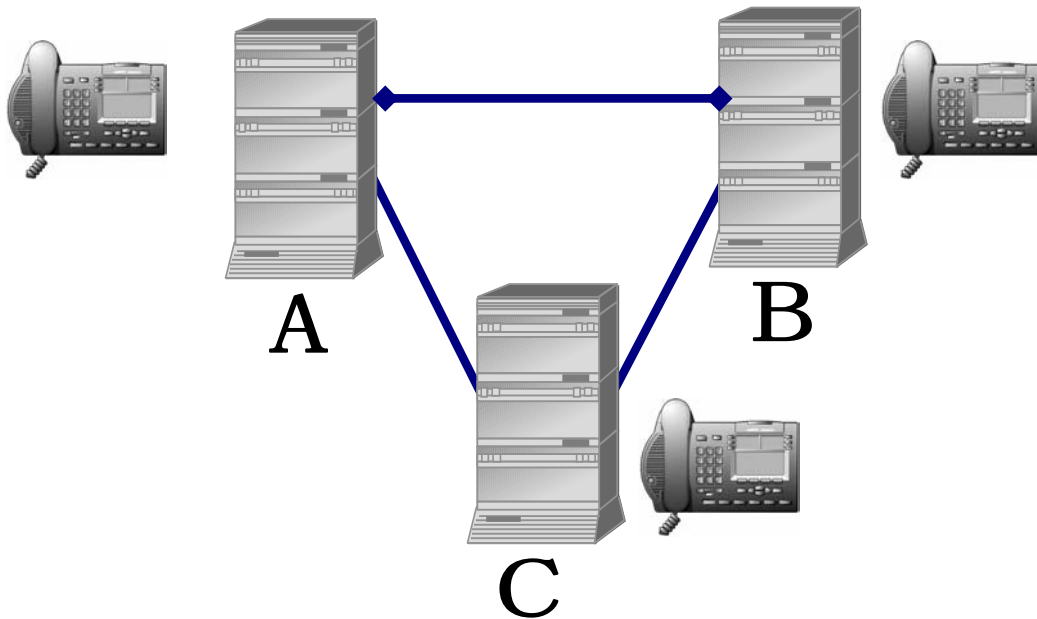
Three nodes scenario:

Station A on Node A calls Station B on Node B.
Station B transfers the call to Station C on Node C.

Node A (pre-Succession 3.0), Node C (Succession 3.0), Node B can be running any Release

TROCM will fail to trigger and no patch is necessary.

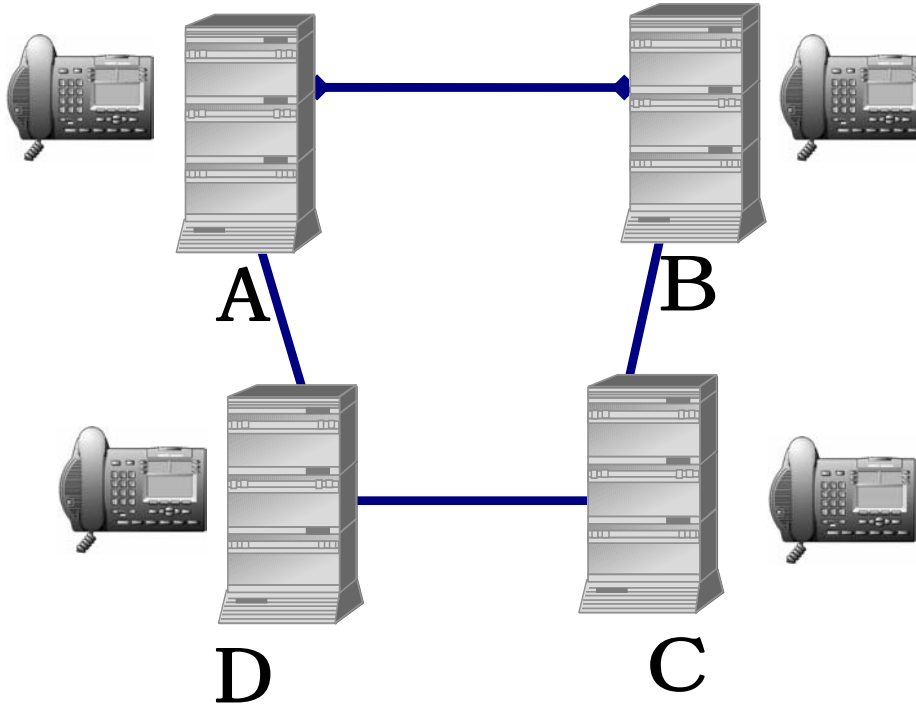
Four nodes scenario:

Node A (pre-Succession 3.0), Node B and Node C (Succession 3.0), Node D(pre Succession 3.0)

Prior to Succession 3.0, TRO FAC IE was exchanged only in FACILITY messages. TRO-CM introduced TRO FAC IE in SETUP, CONNECT and DISCONNECT messages.
