IP Telephony Clients

IP Phone 2007 Firmware Release Notes

Product Release:	0621C23
Document Version:	1.0
Document Release Date:	July 19, 2005

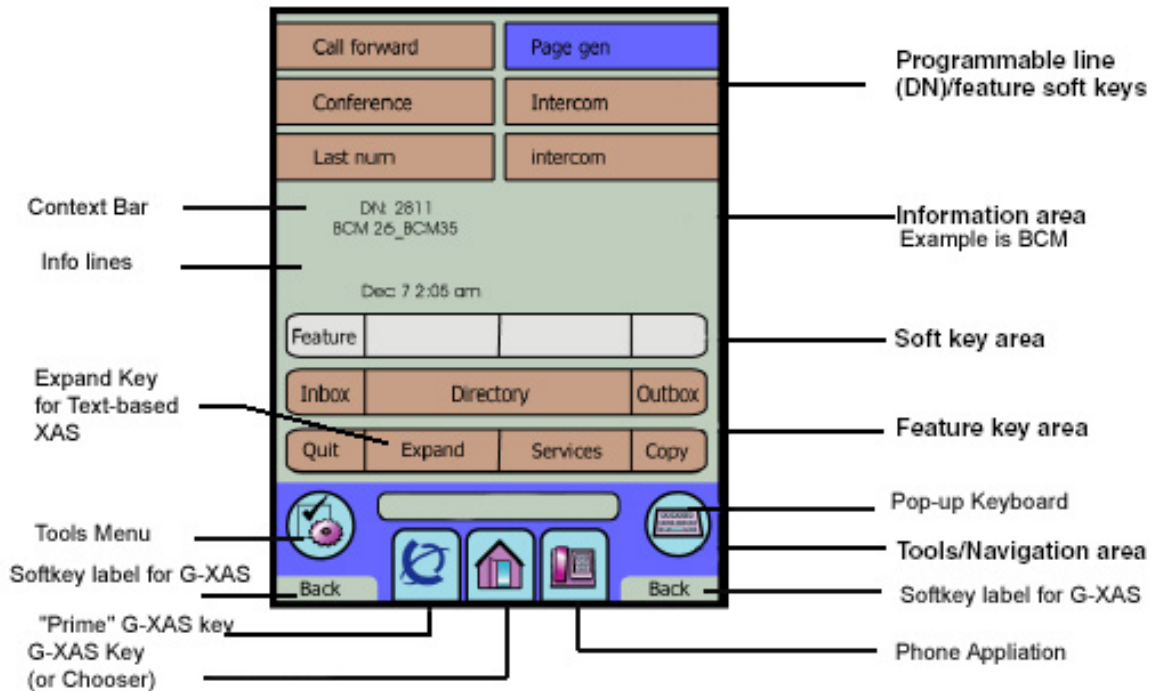
Figure 1: BCM Display below shows an example of the Prime key; with Nortel as the prime external application, the Globe logo shows on the Prime key.

(Note: example intended for reference only; GUI not exactly as illustrated)
